Re: March 2017 Monthly Progress Report  
Administrative Settlement Agreement and Order on Consent for Removal Action  
U.S. EPA Region 10 Docket No. CERCLA 10-2009-0255  
Gasco Sediments Site within the Portland Harbor Superfund Site

Attachment A Monthly Visual Monitoring Report for Pilot Cap Vicinity

# Visual Observations Log Form

**Project:** NW Natural – Gasco

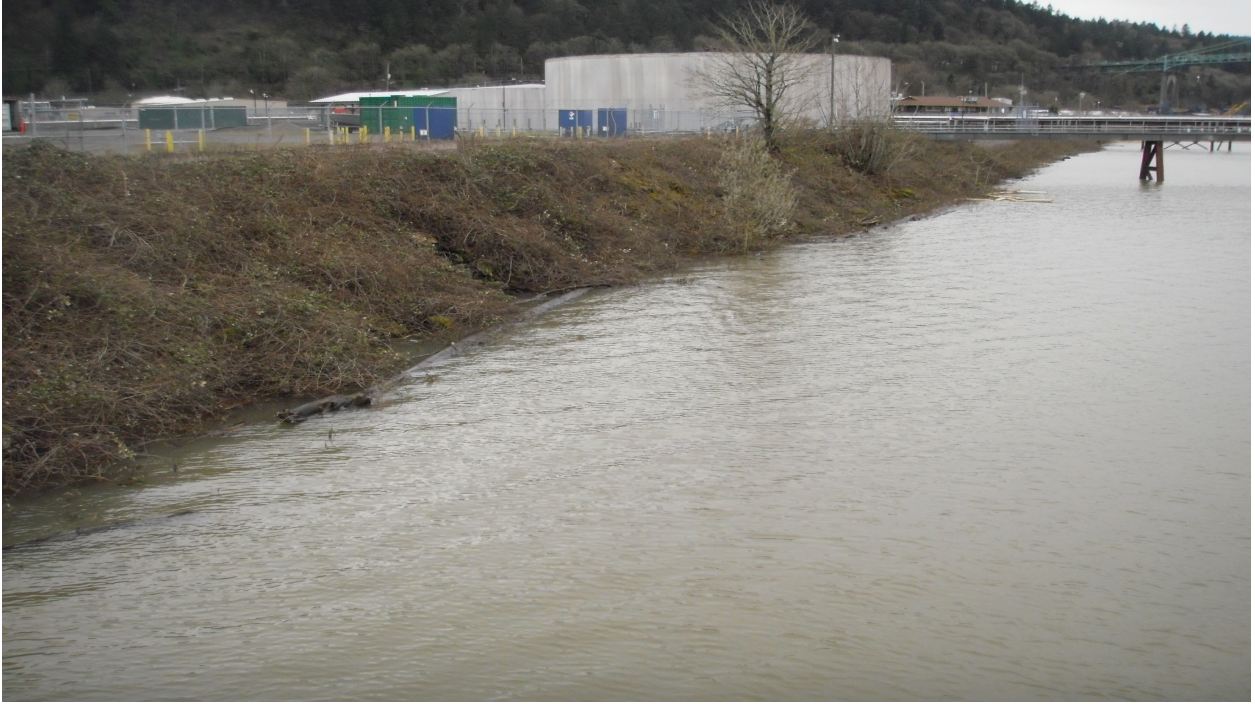
**Photo 1**

No erosion/deposition is evident along the shoreline. The shoreward extent of the cap was not visible due to high river water elevation and the organoclay mat material shoreward of the cap area could not be observed (Photo 1).

**River Level Currently Above the Extent of Sediment Cap (3/20/2017)**

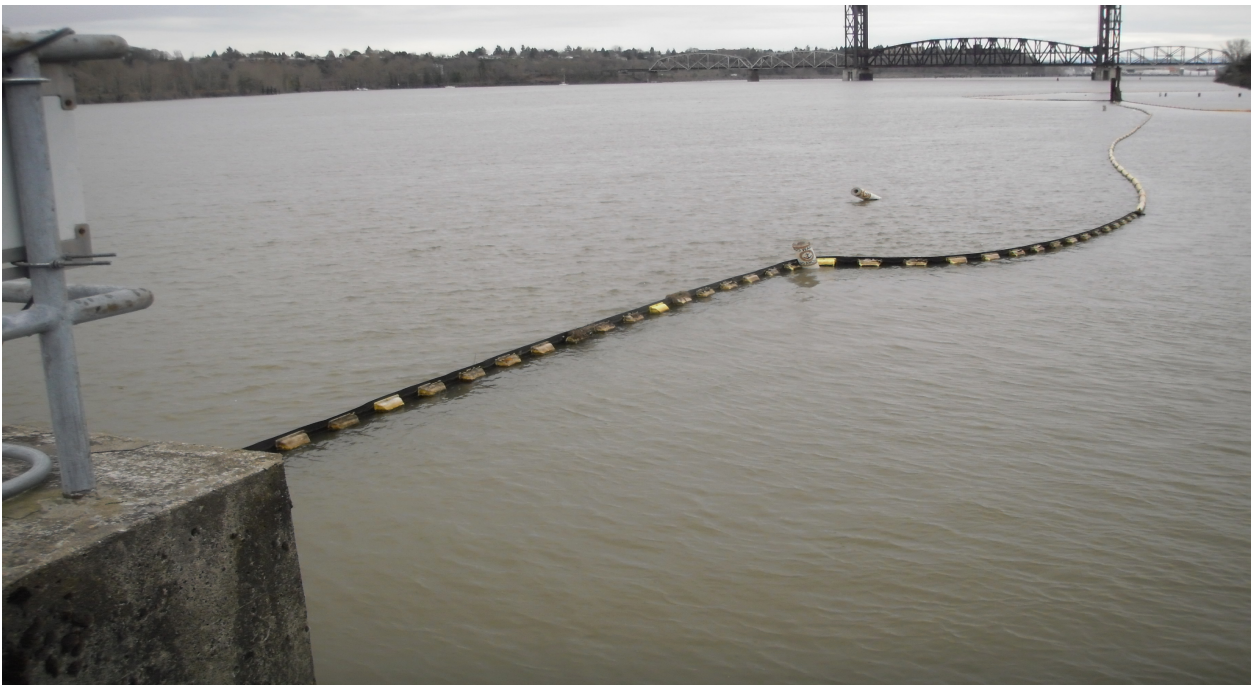
**Photo 2**

During the observation, the FAMM containment boom was placed across the cap area from the ship dock to the upriver dolphin. Two buoys that identify the cap area to mariners are in place as installed. The positions of the FAMM oil boom and warning buoys are shown in Photo 2.

**FAMM Oil Boom Placement and Mariner Warning Buoys at Pilot Cap Area (3/20/2017)**

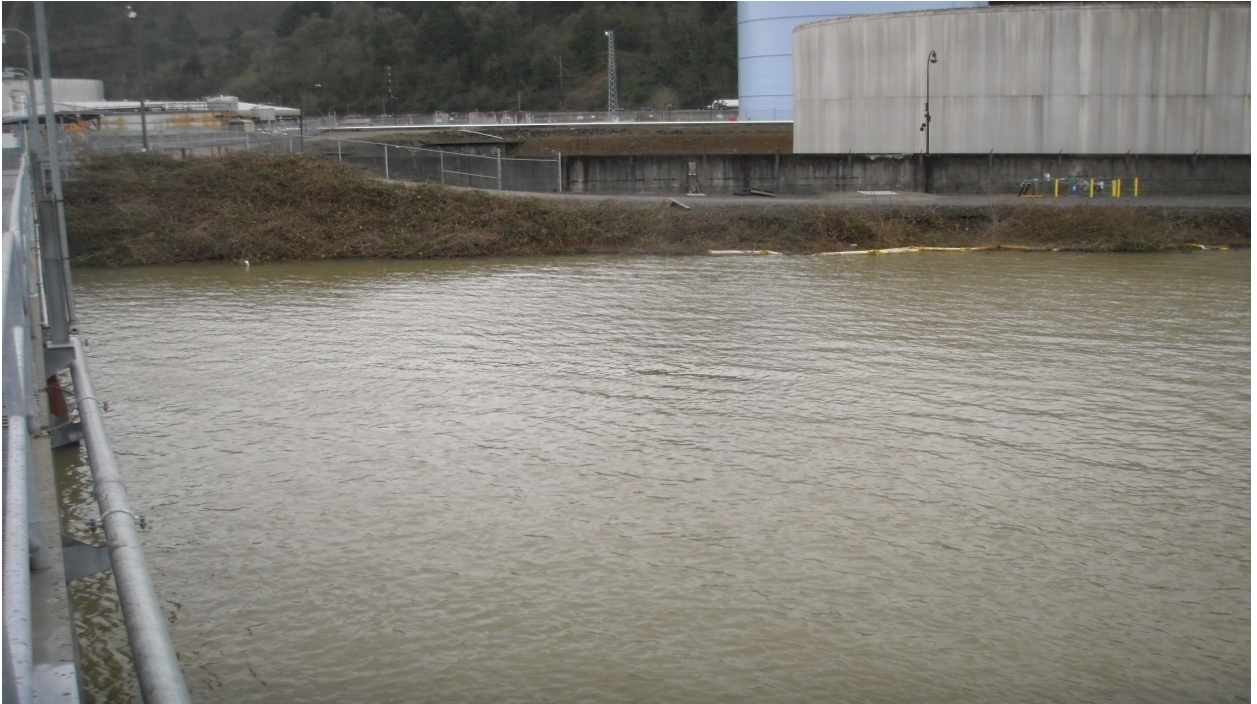
**Photo 3**

No sheen is evident in or around the cap area. Photo 3 shows the water surface and shoreline immediately downriver of the sediment cap.

**Conditions Immediately Downriver of Cap Area (3/20/2017)**
